The Rosepark carehome fire: investigation, research, and finding the lessons to be learned: 6 December 2011 - BRE, Watford

Full Scale Reconstructions of the Rosepark Fire

Martin Shipp
Technical Development Director, Fire Safety
BRE Fire and Security

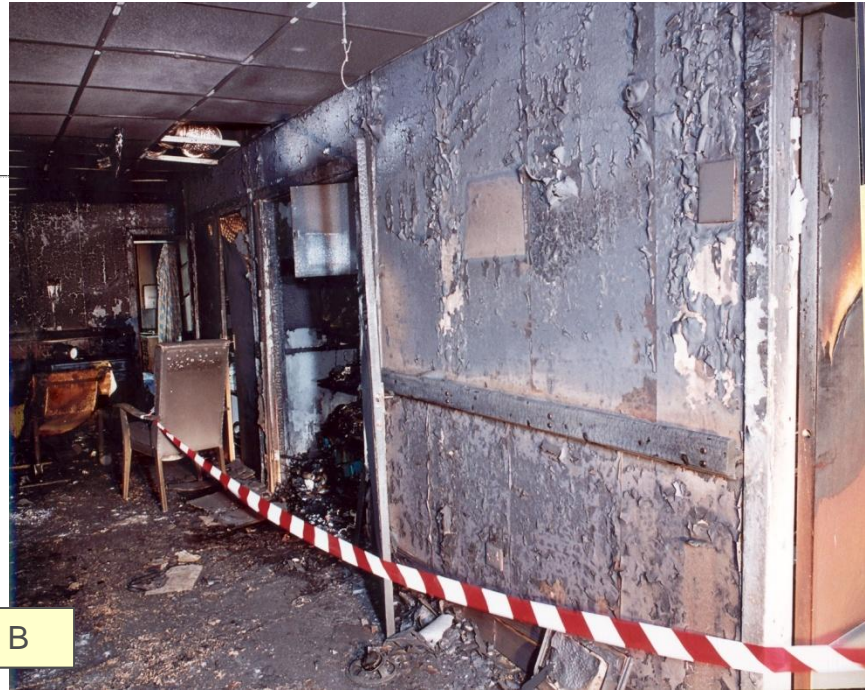
After the fire – view B

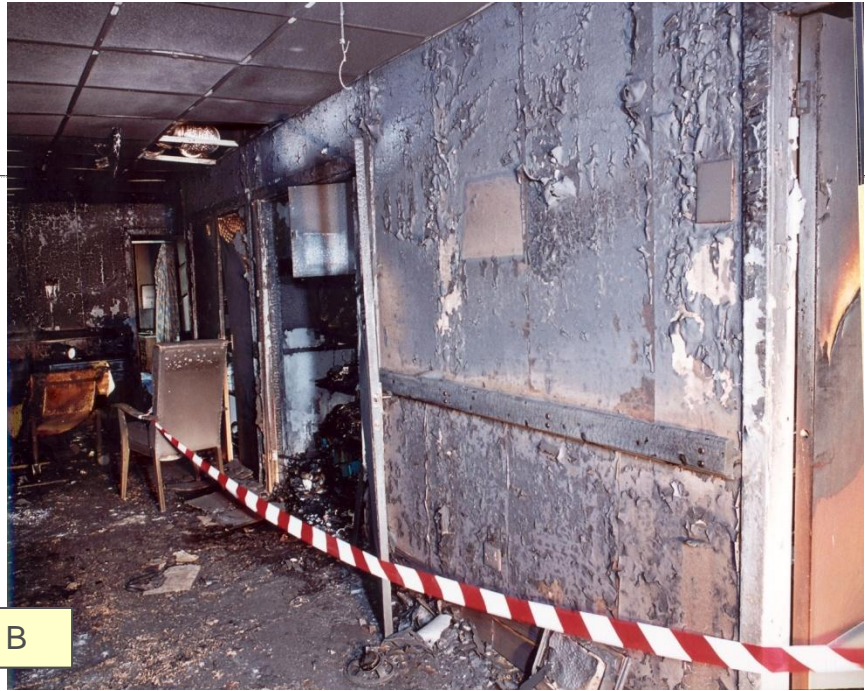
After the fire – view B

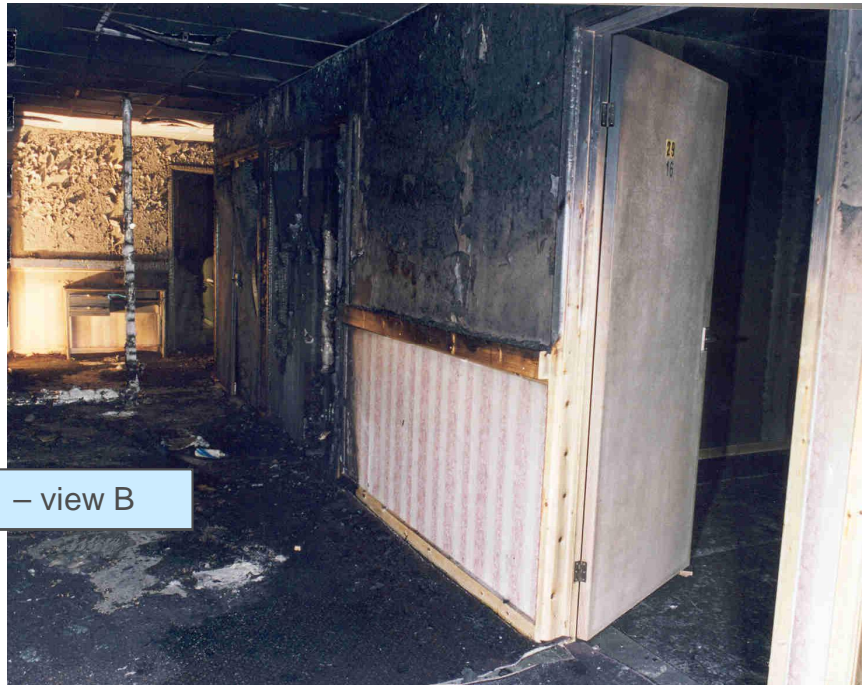
After Test 1 – view B

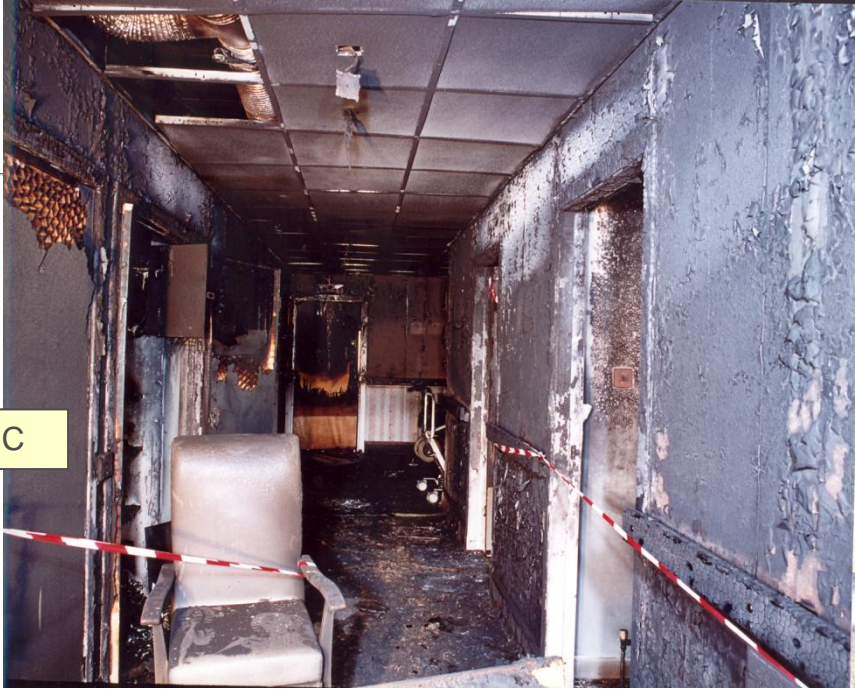
After the fire – view C

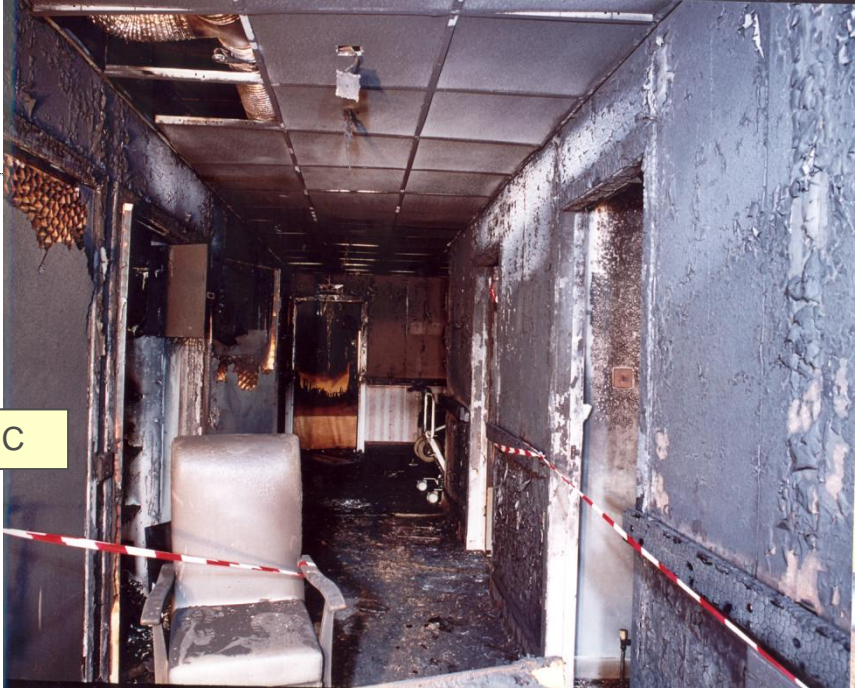
After the fire – view C
