## Annex B – Plenum Spaces

### Introduction

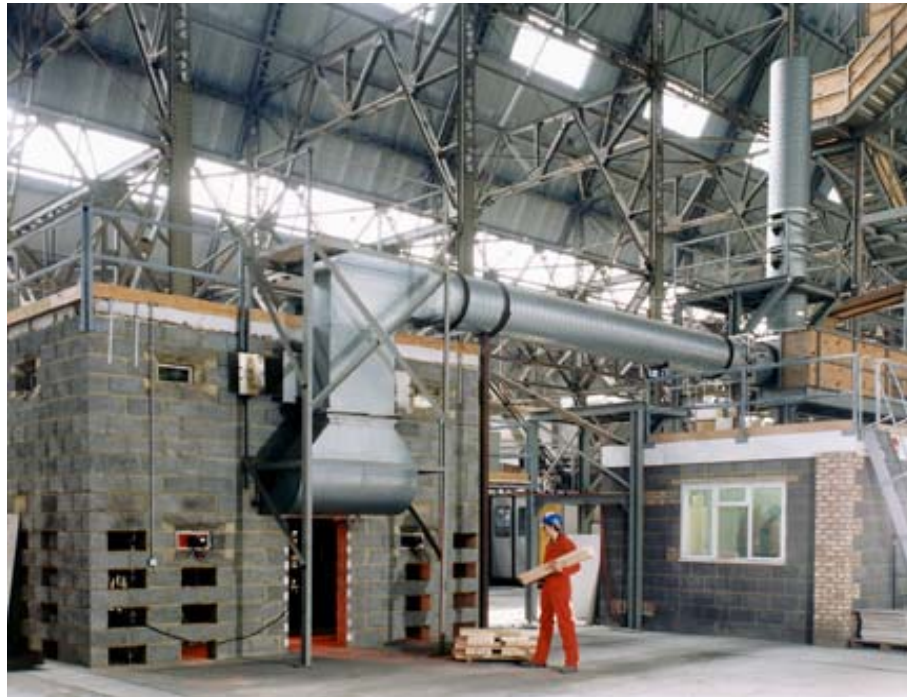
**Photograph B1. BRE Real Scale Cable Fire Test Facility**

The tests were carried out on the BRE Real Scale Cable Fire Test Facility, which is a purpose built fire test scenario that offers a test building, containing a suspended ceiling, linked to an exhaust duct to induce a draft across the test sample in the ceiling void, see Photograph B1. Temperature measurements were taken in the ceiling void and the fire room below. Measurements of the combustion products generated during the test are made in the exhaust duct to determine the rate of heat release.

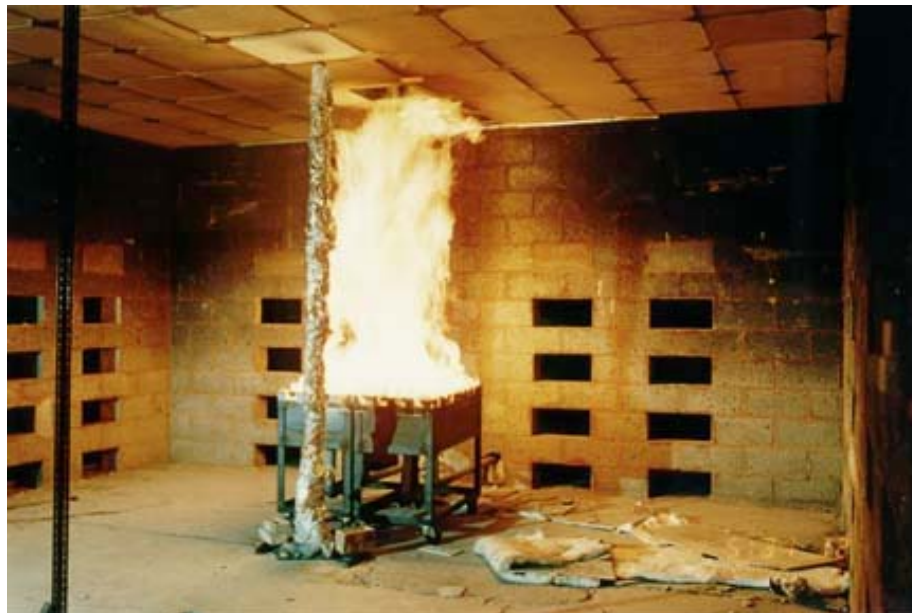
**Photograph B2. 1 MW gas burner with flames entering ceiling void**

A 1 MW methane gas burner was placed below a missing ceiling tile in each test see Photograph B2, 1.5 m along the support ladder, with the burner flames impinging upon the underside of the test cable. The smoke and combustion products were initially withdrawn from the ceiling void by an induced draft at the opposite end of the ladder from the gas burner, into an exhaust duct, for further analysis.

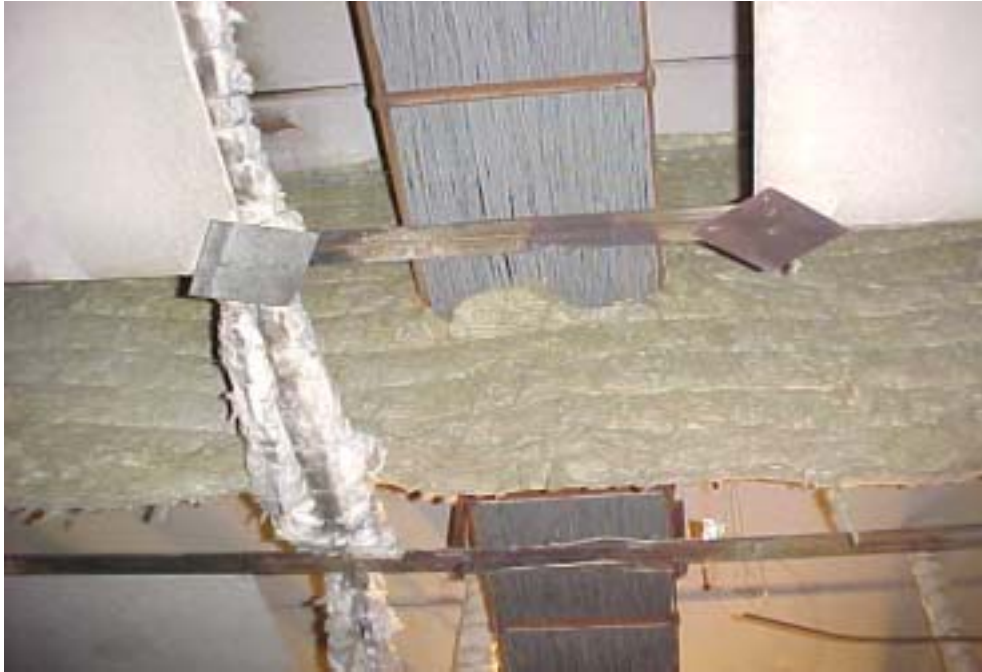
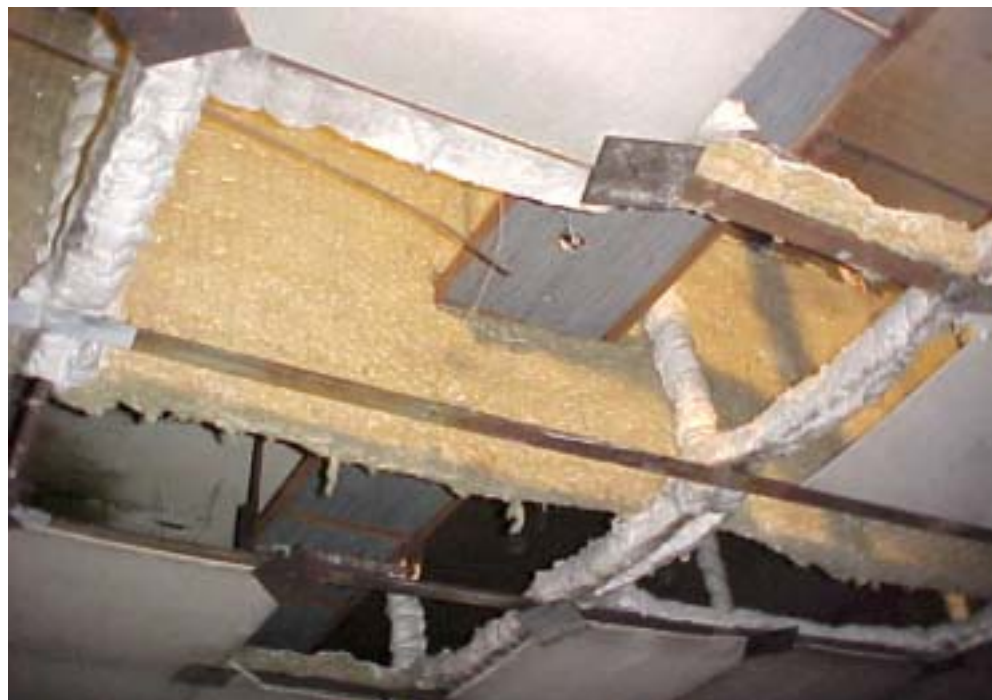
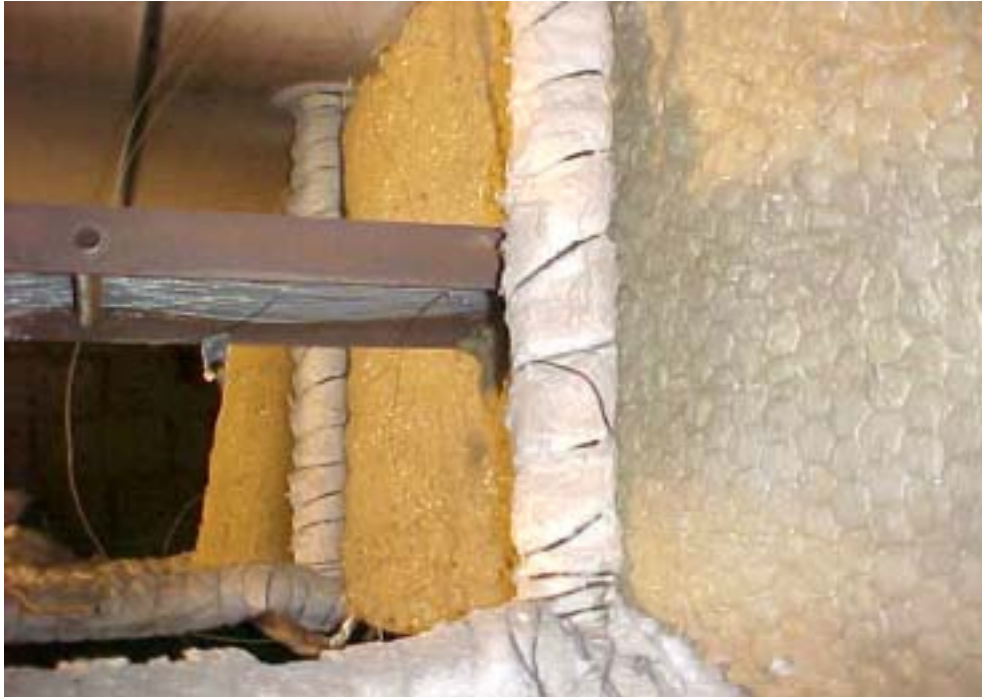
**Photograph B3. Cable ladder running through the cavity barrier.**

**Photograph B4. Cable ladder running through the cavity barrier.**

**Photograph B5. Thermocouples on the exposed side to the burner.**

- Test 1 - 'Control' test with no cavity barrier system installed within the ceiling void.
- Test 2 - Test with a cavity barrier system installed and the cables running through the cavity barrier without the use of fire stopping, see photographs B3 to B5.
- Test 3 - Test with a cavity barrier system and fire stopping installed. The cable ladder was also wrapped on both sides with the cavity barrier material with 1m length next to the burner and 0.6m on the opposite side, see photographs B6 to B8.

In Tests 2 and 3 the cavity barrier was installed 2.9m from centre of breech hole, 4.4m from end of rig the layout of the barrier, see photograph B4. The cavity barrier systems used for these tests was a commercially supplied system designed to meet the ½ hr fire resistance requirements set out in AD B. It was installed in accordance with manufacturer's instructions.

The visual observations made during the tests are summarised in Table 4 below. The layout of Test 2 can be seen in photographs B3,B4 and B 5.

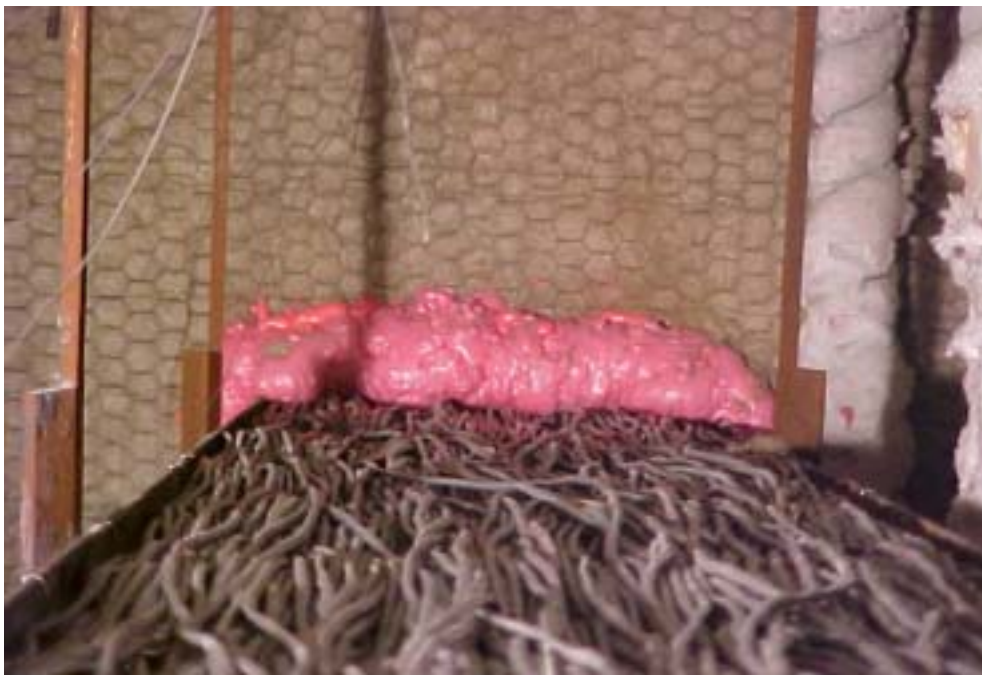
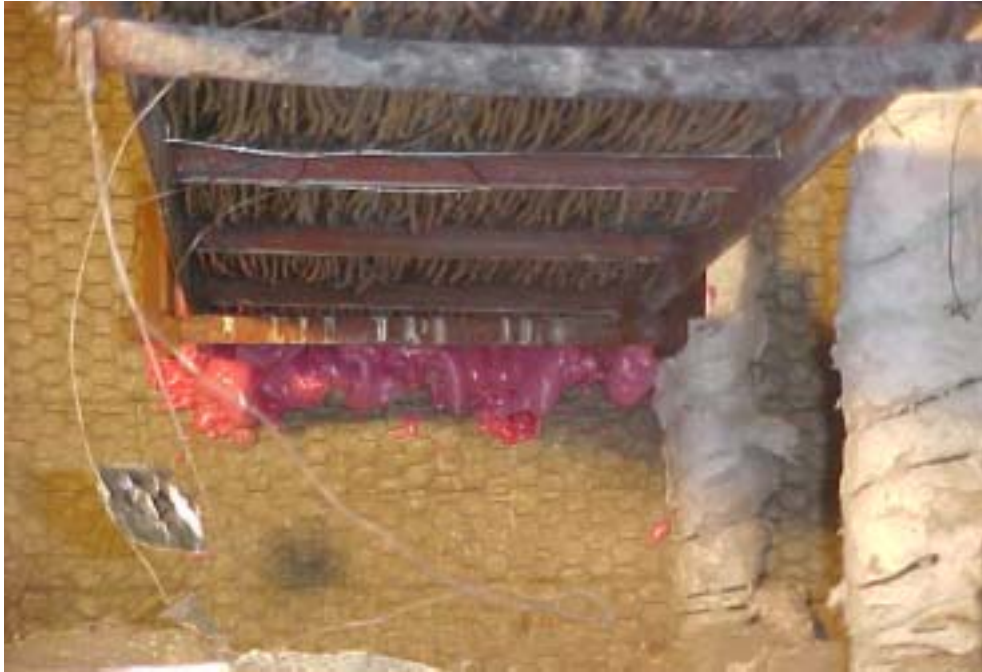
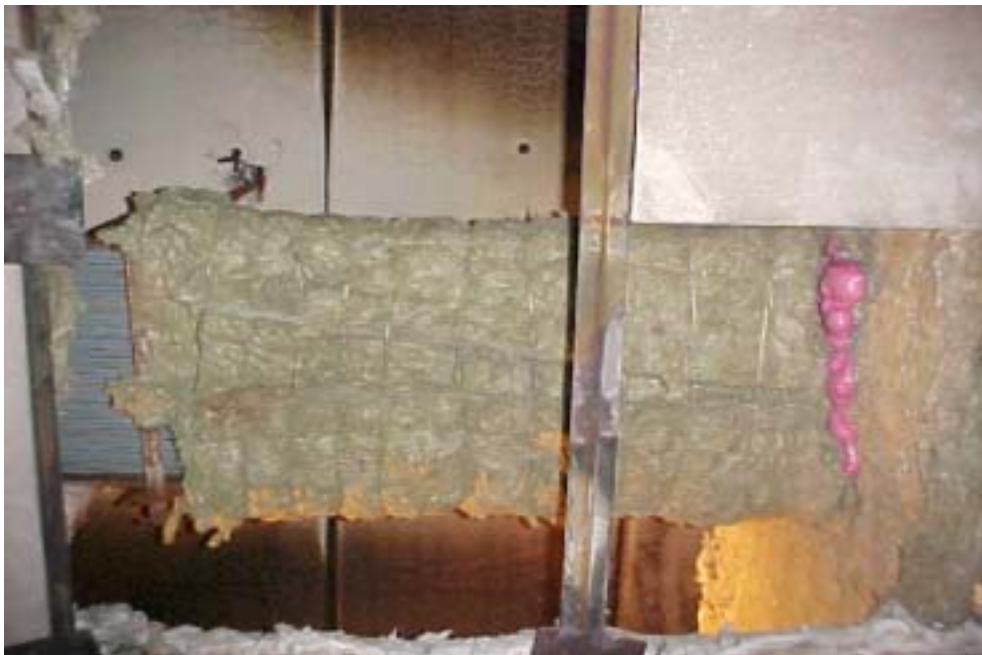
**Photograph B6. Fire stopping in the cable ladder adjacent to the cavity barrier.**

**Photograph B7. Fire stopping to the underside of the cable ladder adjacent to the cavity barrier**

**Photograph B8. Fire stopping adjacent to the cavity barrier also shows the wrapping around the cables.**

The cavity barrier was installed with the cables running through the cavity barrier and fitted with fire stopping. The cable ladder was also wrapped on both sides with the cavity barrier material with 1m length next to the burner and 0.6m on the opposite side, see photographs B6 to B8. The visual observations made during the tests are summarised in Table B6 below.

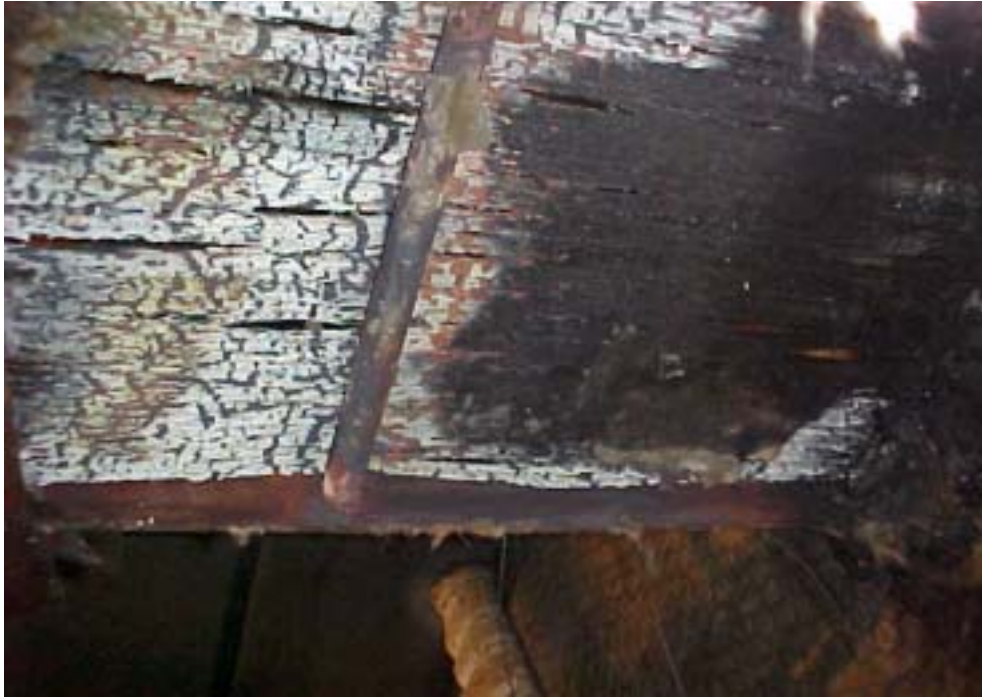
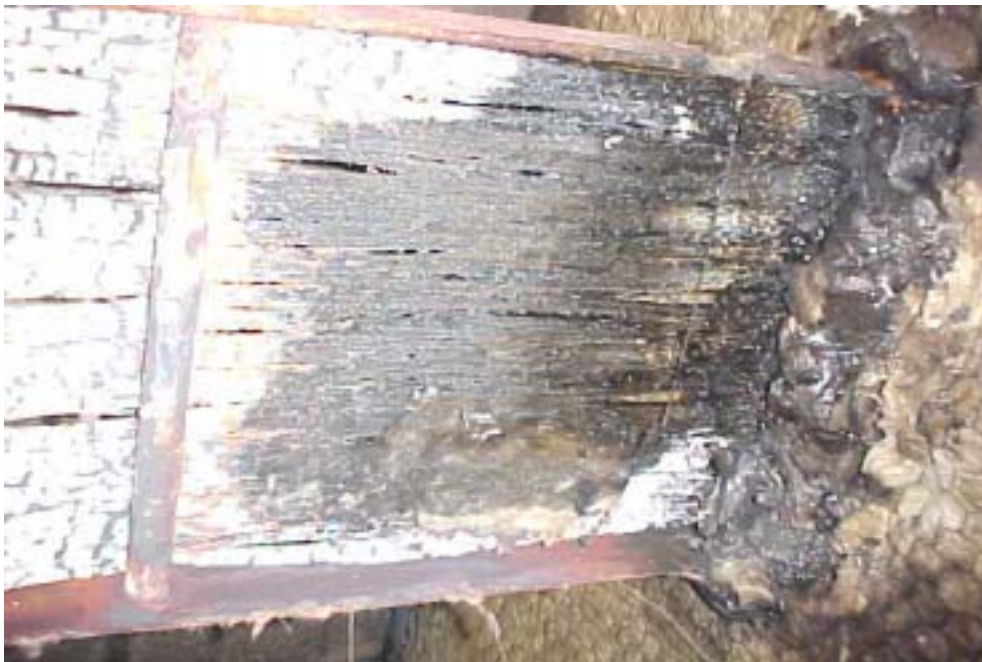
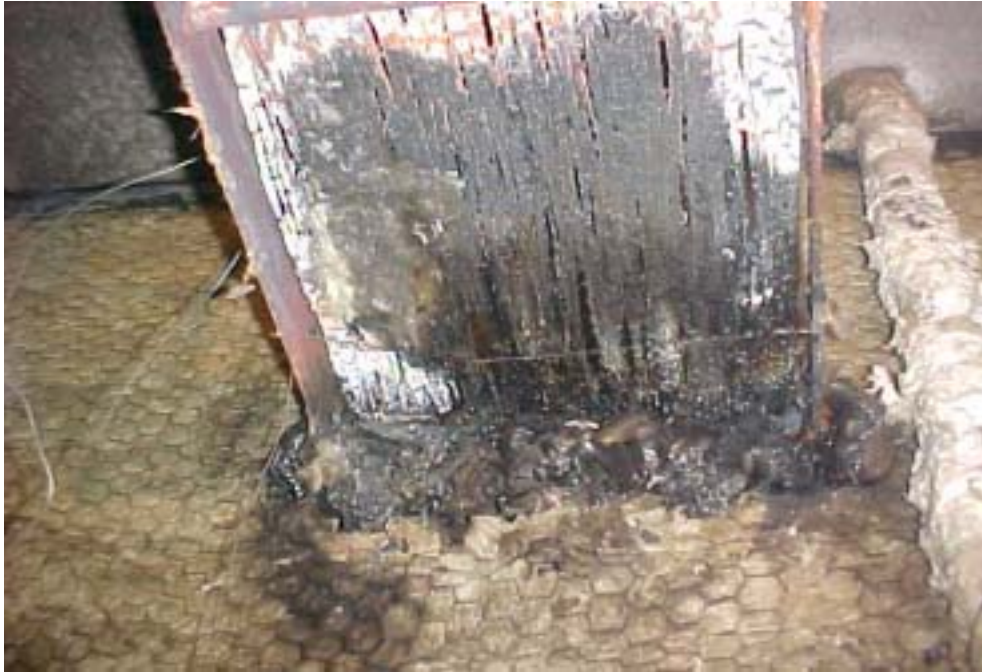
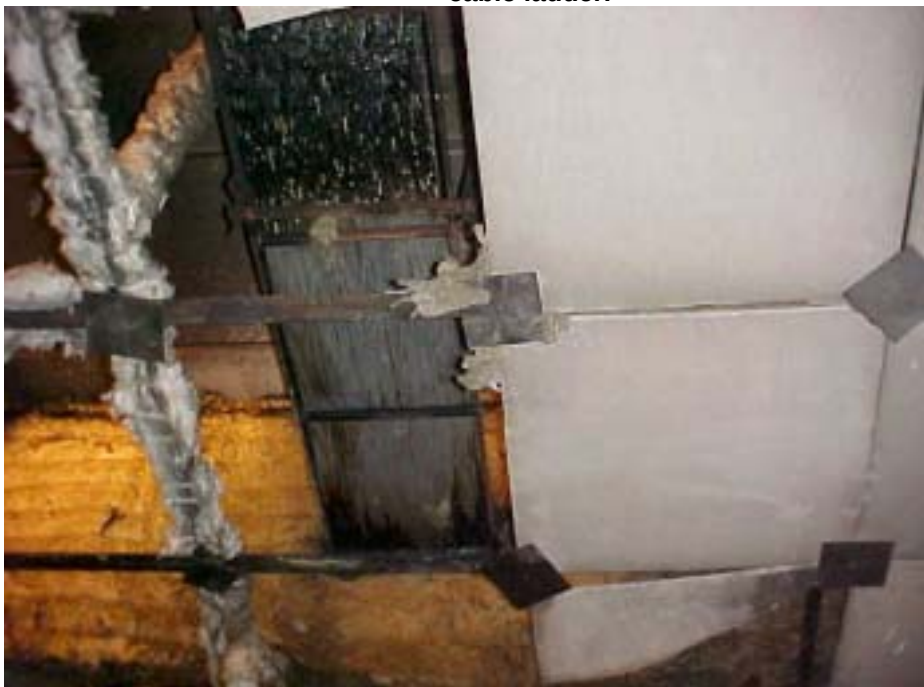
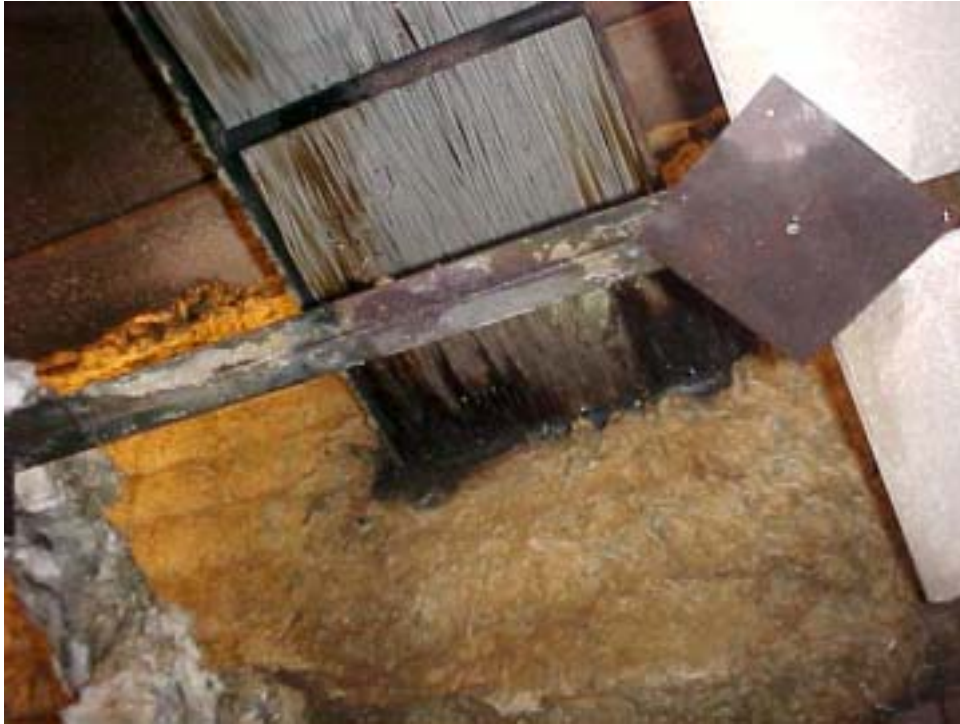
**Photograph B9. Post test in the ceiling void with a cavity barrier.**

**Photograph B10. Cavity barrier with fire stopping around the cable ladder.**

**Photograph B11. Underview of the cavity barrier with fire stopping around the cable ladder.**

**Photograph B12. Burner flame impingement on the cable ladder**

**Photograph B13. Fire spread from the underside of the cavity barrier.**

1. Damage on the burner side appeared to be caused by smouldering/growing of material soaked into the cavity barrier, this reignited when the smouldering reached the barrier was exposed to air, see Photograph B10.

The introduction of fire stopping around the cavity barrier, in Test 3, significantly slowed the rate of fire progress and the flame front did not reach the end of the cable ladder. On examination of the ladder after the test, all burning had been confined to the fire side of the barrier, that is, the fire did not pass the cavity barrier. When the unexposed side of the barrier wrap was removed, the cables beneath the wrap were fused together but appeared unburnt. Photographs B9 to B13 show the post test damage.
