The Rosepark carehome fire: investigation, research, and finding the lessons to be learned: 6 December 2011 - BRE, Watford

Full Scale Reconstructions of the Rosepark Fire

Martin Shipp
Technical Development Director, Fire Safety
BRE Fire and Security

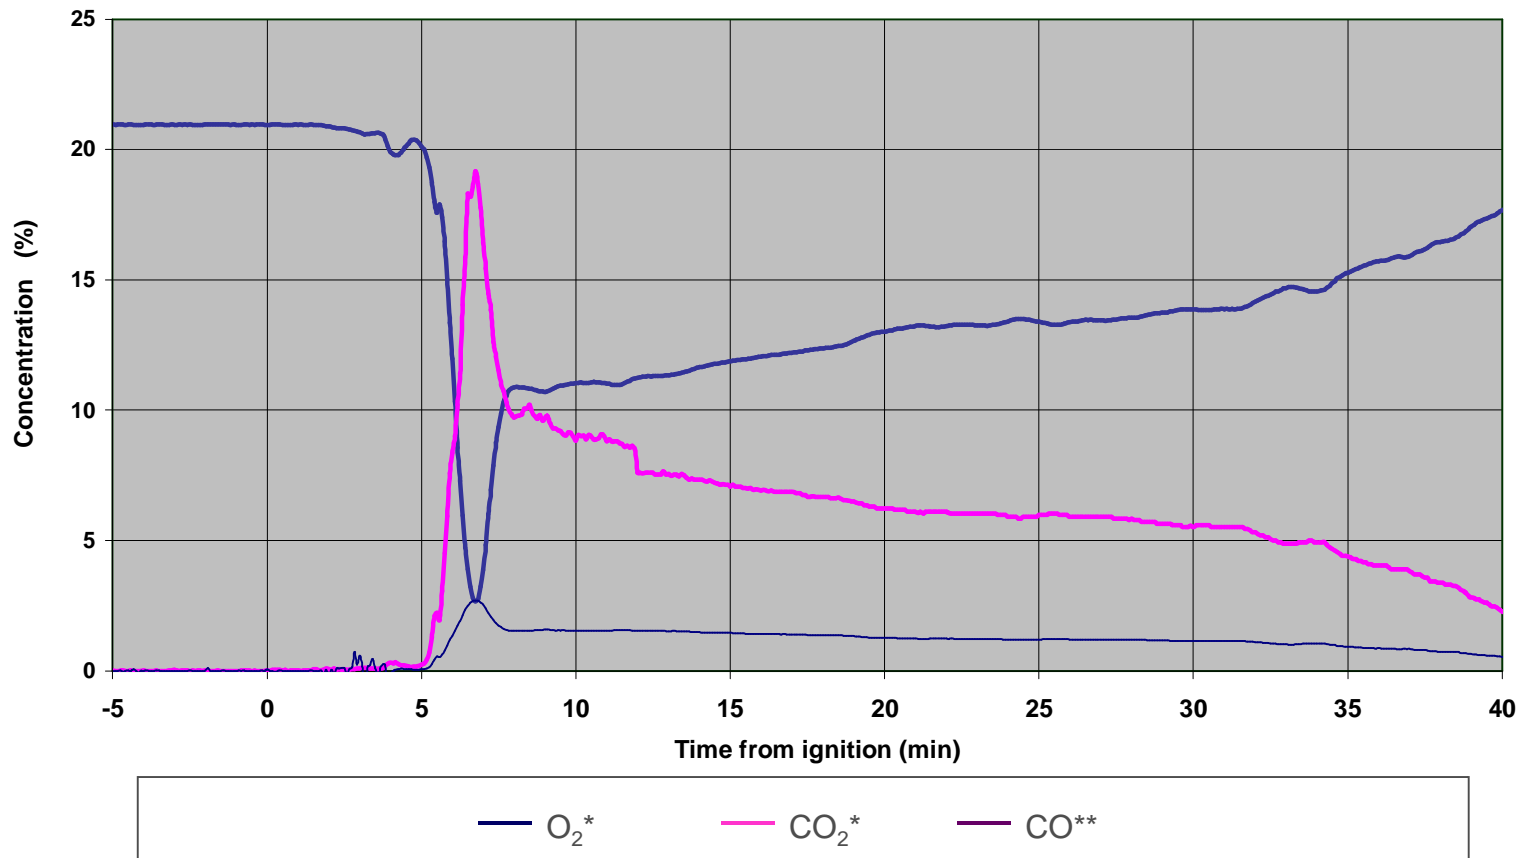
Test 1 : Concentration of Oxygen, Carbon Dioxide & Carbon Monoxide
Corridor 4B

* Values derived from logged data with a leakage factor applied.
** Derived from calculated O2 depletion.

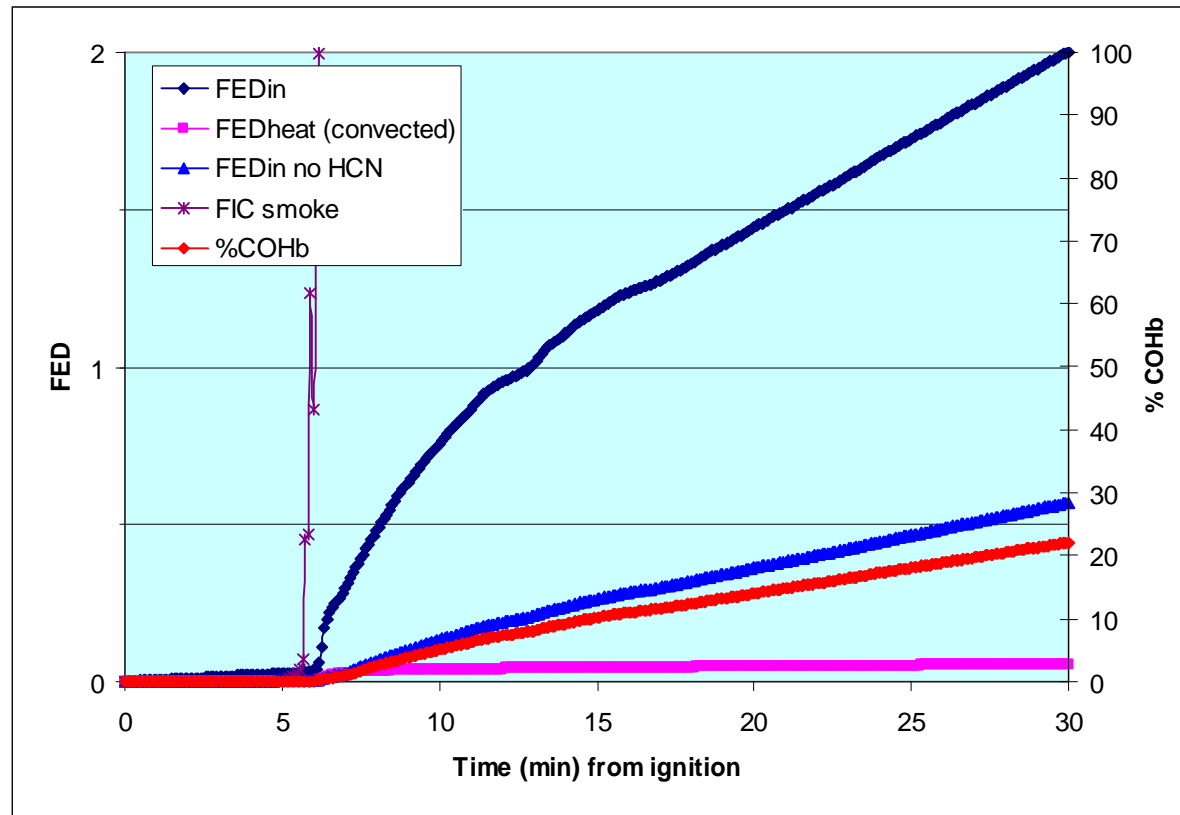
Predicted times to incapacitation endpoints for a subject in the in the corridor beyond the partly closed fire resisting door (Corridor Z) Corridor 3

- The reportedly poor fitting fire door separating Corridor 3 from Corridor 4a/4b would have allowed the penetration of heat and potentially asphyxiant gases into the corridor and associated open bedrooms. (Alternatively, this door was blown open by exploding aerosols and became stuck open).
- The presence of a residential sprinkler system, if available on the night of the incident, would not have extinguished the fire but would probably have rendered conditions in all areas tenable for at least 1 hour.
- The fitting of fire doors with smoke seals to all bedrooms, and keeping them closed during the fire, would not have prevented untenable conditions in the corridor but would largely have prevented heat and asphyxiant gases penetrating the bedrooms. Occupants in bedrooms behind closed doors would probably have escaped incapacity for up to 2 hours.

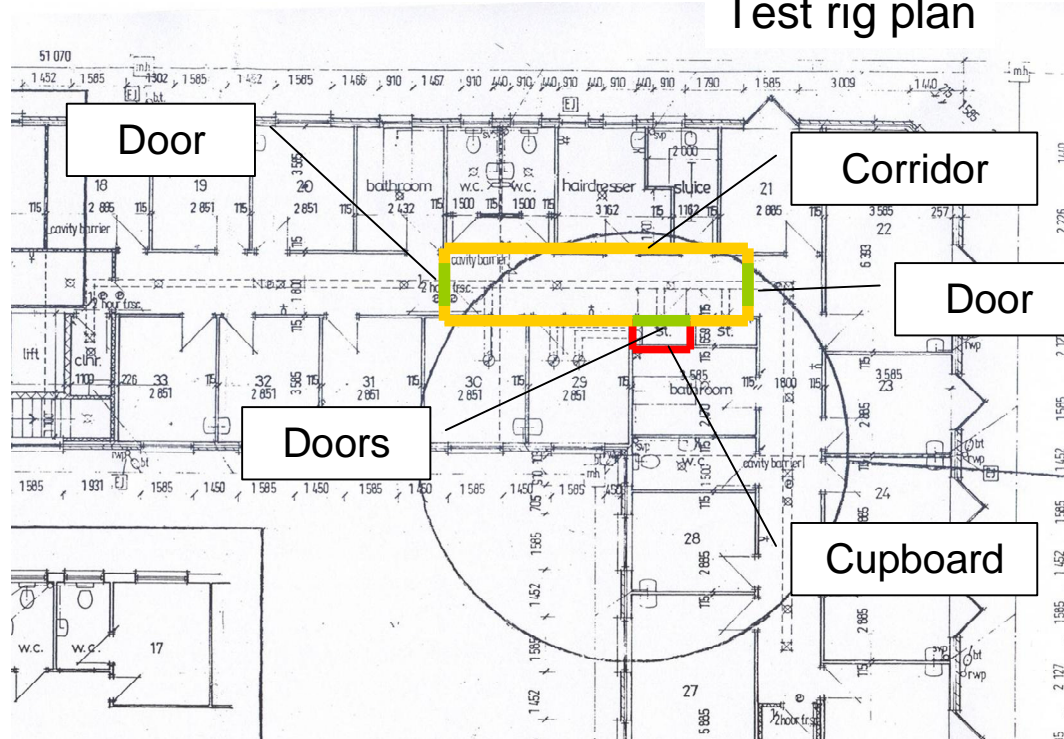
Test rig plan

TC Cupboard lower – 0.66m from floor
TC Cupboard upper – 2.1m from floor

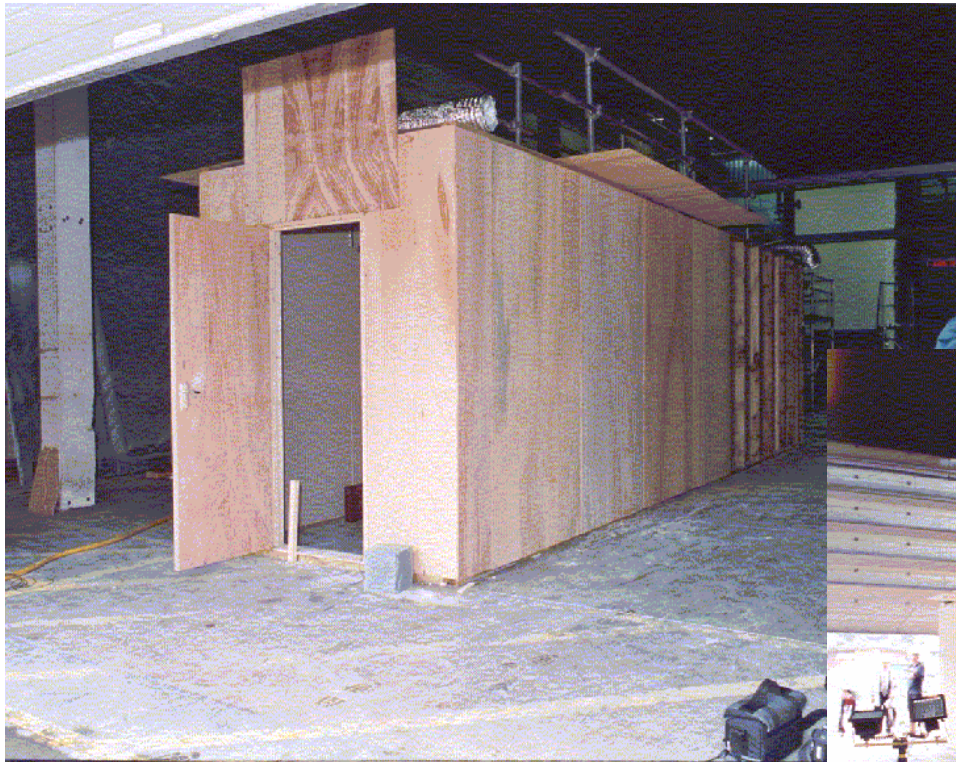
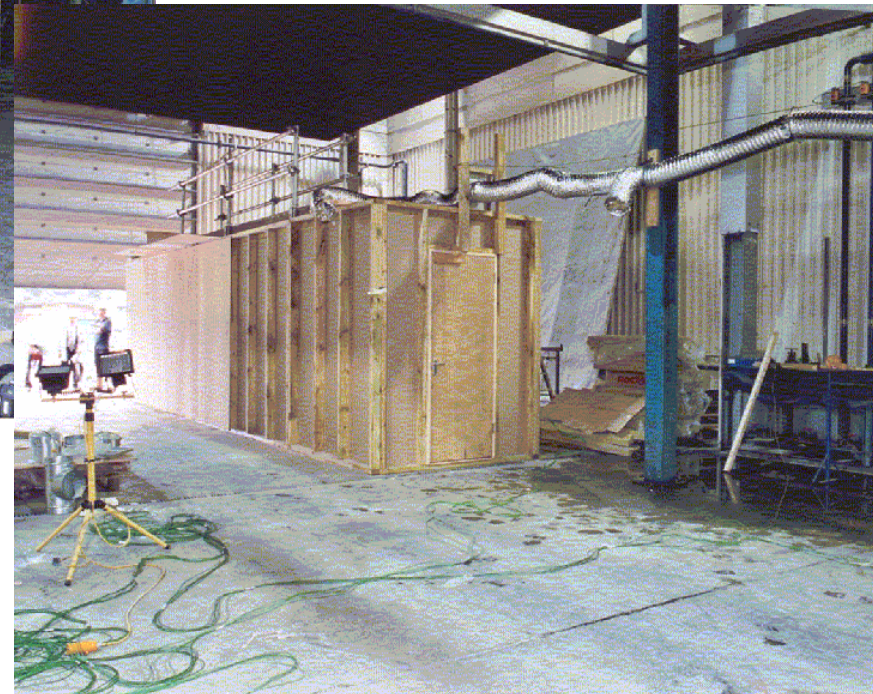
COPFS ducting test

- Would the volume of smoke passing through the ventilation system into Corridor 3 have presented any hazard to the safety of the residents in the bedrooms there? Would a fire damper in the duct at the wall between Corridors 4 and 3 have had any effect on the flow of smoke into the Corridors 3 or 2?
- The tests indicated that the volume of smoke that is likely to have travelled from the initial cupboard in Corridor 4 to Corridor 3 via the ventilation ducting may not, by itself, have been hazardous, i.e. noting that fatalities occurred in rooms off Corridor 3, the quantity of smoke that passed through the ventilation ducting was probably supplemented by smoke that travelled by another or other routes, most probably via the Corridor 4/3 fire door.

- How fast would smoke pass through the system; how much smoke could travel in this manner?
- The tests have demonstrated that smoke is likely to have travelled from the initial cupboard in Corridor 4 to Corridor 2 and Corridor 3 via the ventilation ducting within 3 or 4 minutes of ignition. If the fan had been operating then this may have stopped smoke travelling into Corridor 2 and Corridor 3 and smoke would only have travelled into Corridor 2 after the ventilation system fan (in the roof) failed.

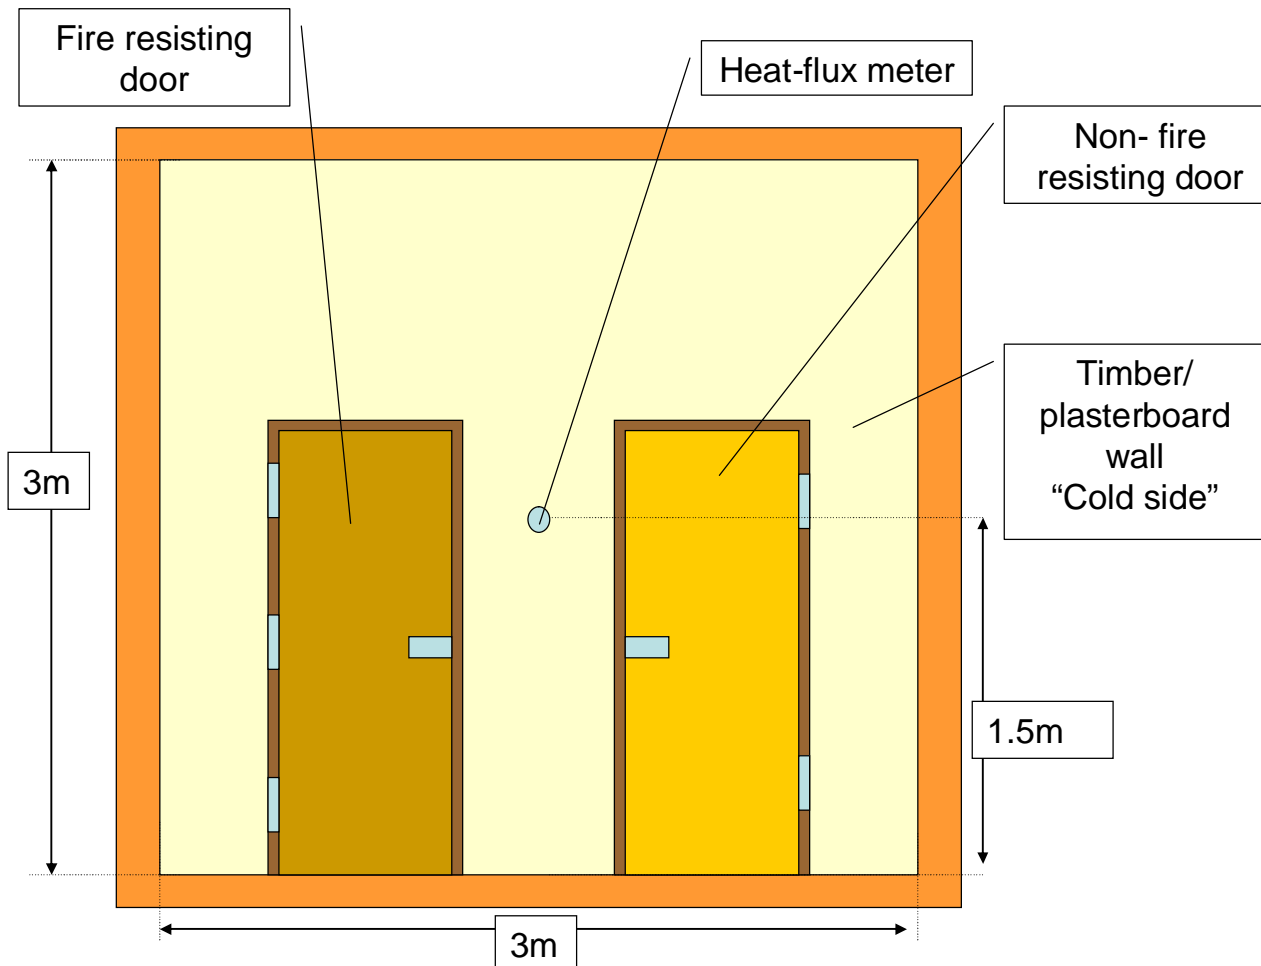
COPFS door test

- What difference would it have made on the night of the actual fire if all the bedroom doors had been shut?

- What difference would it have made on the night of the actual fire if all the bedroom doors had been shut?
- Test 6 demonstrated that an “egg box” door can withstand the test conditions of a fire resistance test for a period of only 7 minutes.
- It was my opinion that it is likely that most, and probably all, of the non-fire-resisting doors (had they all been closed) would have withstood the fire in the corridor for a period sufficient for the fire to die back from lack of air, such that fire penetration into any of the bedrooms is not likely to have occurred.
